Journal of Civil Engineering Researchers

A review on progressive collapse and its types

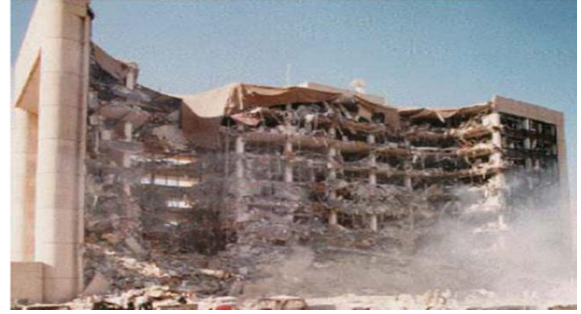
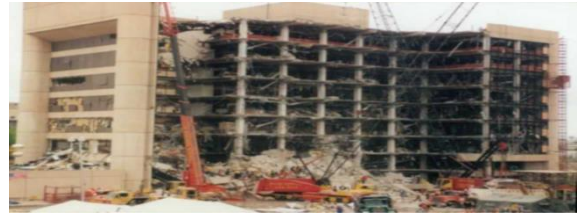
Fig.1. Progressive collapse in Alfred P Murrah

It was designed and built in Oklahoma City between 1970 and 1976 as an administrative building for the United States government. On April 19, 1995, an explosion on the north side hit a truck. The structural system consists of a nine-story reinforced concrete frame. Its particularity is the presence of a Transfer girder⁵ on the third floor on the north side. Thus the columns on the ground floor are twice as far apart as on the other upper floors. The explosion destroyed all three columns and the entire cantilever was eventually moved, as shown in Fig. 1. The accident was considered an example of progressive failure due to the inability of the transport frame and beam system to handle the increased anchorage and shear forces near the three columns that were removed at the level of the ground [1].

Some progressive collapse does not fit completely into the above categories. The partial destruction of the Alfred P Murrah building shows not only a pancake scenario, but also some characteristics of a domino scenario.

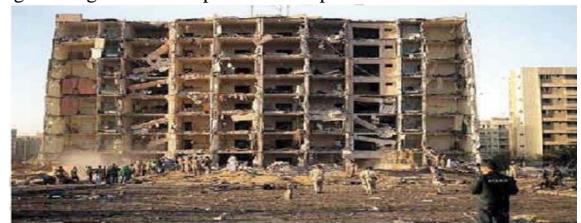
Fig. 3. Kobar towers

Kobar Towers was one of several apartment buildings in Al-Kobar near Dhahran, Saudi Arabia. On June 25, 1996, one of the apartment buildings was severely damaged when a heavy bomb exploded on the street in front of the building (Fig. 3). The eight-story Kobar Towers building was built with a T-shaped plan and a system of prefabricated reinforced concrete walls and roof. All vertical and lateral loads were supported by the prefabricated wall system. Although the shear wall was destroyed by the blast, damage was limited to the opposite and exterior openings leading to the building, and only continued within the initial damage zone. Research shows that precast reinforced concrete systems are plastic enough to handle abnormal events. In addition, the connections within the ceiling and walls remain mostly intact and unbroken [2].

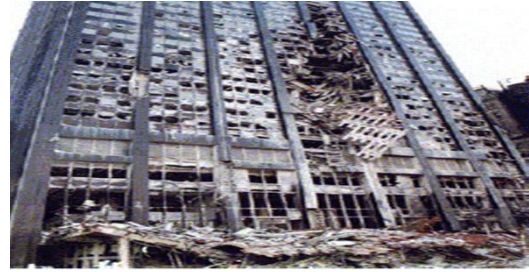
Fig. 4. Bunkers Trust

This building is an example of undisturbed architecture remaining from progressive collapse. This 40-story building was built in the early 1970s in New York. Right on the site of the original South World Trade Center. The structural system consists of a steel frame with beams connected to the columns by two-way bent connections. The structure withstood the impact of the debris from the destruction of the South World Trade Center. A portion of the exterior wall of the south tower impacted the 23rd floor of the building, including the roof system damage and perimeter beams between floors 9 and 23, as well as damage to exterior columns between floors 9 and 18, as shown in Fig. 4. Despite the loss of vertical load-bearing members, no additional damage occurred beyond that caused directly by debris from the destroyed South Tower of the World Trade Center. It is clear that the bending frame is ductile enough and sufficient to withstand the distributed load stresses after the column removal and to absorb the kinetic energy generated by the sudden column removal and debris falling [1].

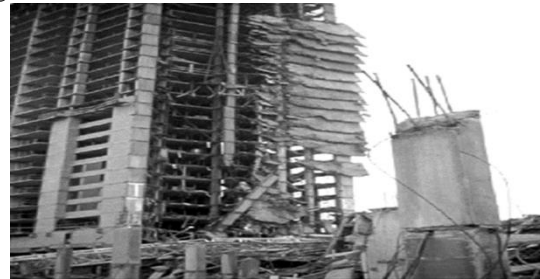
Fig. 5. Sky line plaza

In 1973, during the concreting of floor 24, there was progressive damage to the entire height of the tower, and progressive horizontal damage to the entire parking lot adjacent to the tower due to debris impact [3] (Fig. 5).

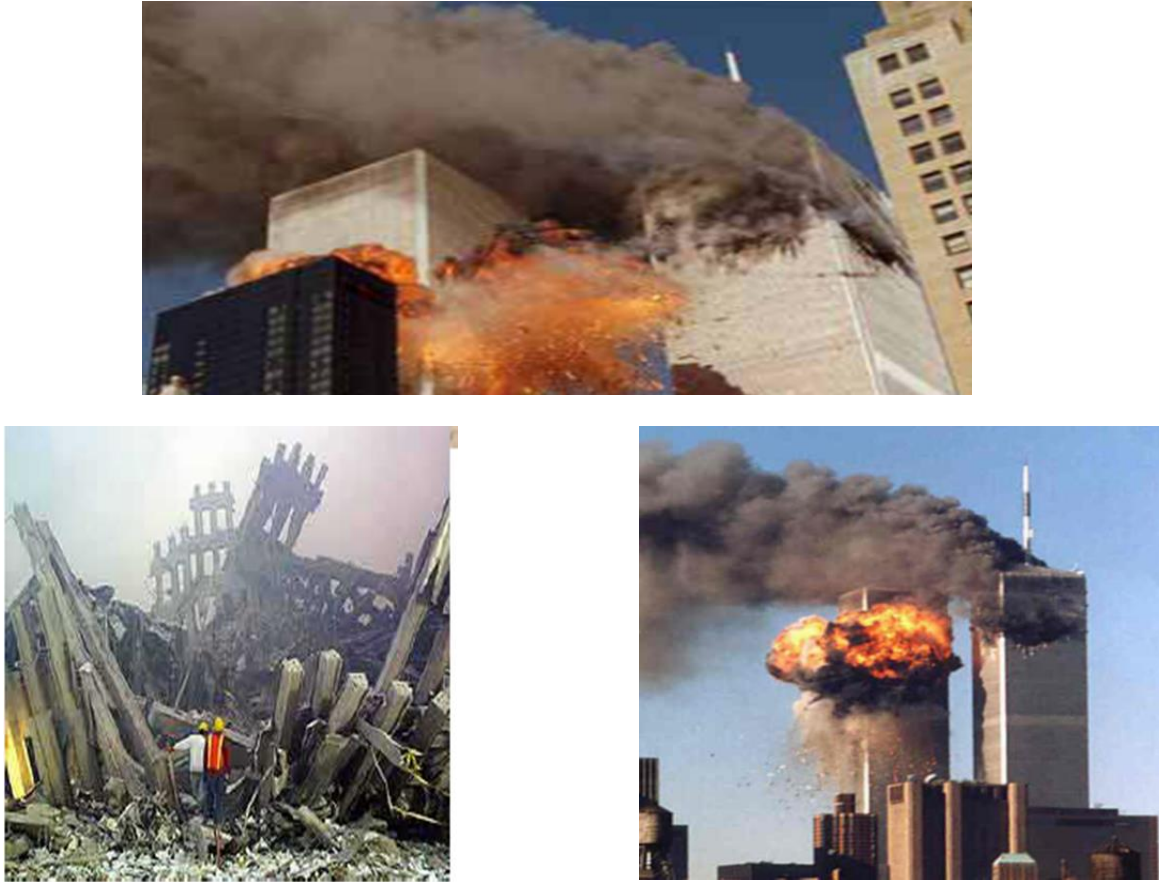
Fig. 6. The world trade center twin towers

The vulnerability of these structures to unusual and unexpected constraints was demonstrated when two aircraft struck the United States' Twin Towers on

September 11, 2001, causing damage and total and partial damage to ten adjacent buildings [4] (Fig. 6).

An example of this type of destruction is the progressive destruction of the World Trade Towers. Airstrikes and fires caused local damage in the impact areas. Therefore, with the loss of load-bearing capacity of a limited number of layers, the upper part of the structure begins to fall and accumulates kinetic energy. The collision with the bottom of the sound results in a large impact force, which is much greater than the bearing capacity of the actual design of the structure. This structural impact causes a loss of bearing capacity of the entire section of the tower within the impact area. The suggested word for this type of destruction was used after the destruction of a smaller building than the Twin Towers. The buildings have shingles stacked on top of each other to form cookie-like objects. This type of destruction mechanism has the following functions:
