Journal of Civil Engineering Researchers

# Comprehensive Sinkhole Mitigation: A Case Study and Application of Compaction Grouting in Karstic Environments in the State of Tennessee, USA

<sup>a</sup> Terracon Consultants, Inc., Nashville, TN, USA 37217

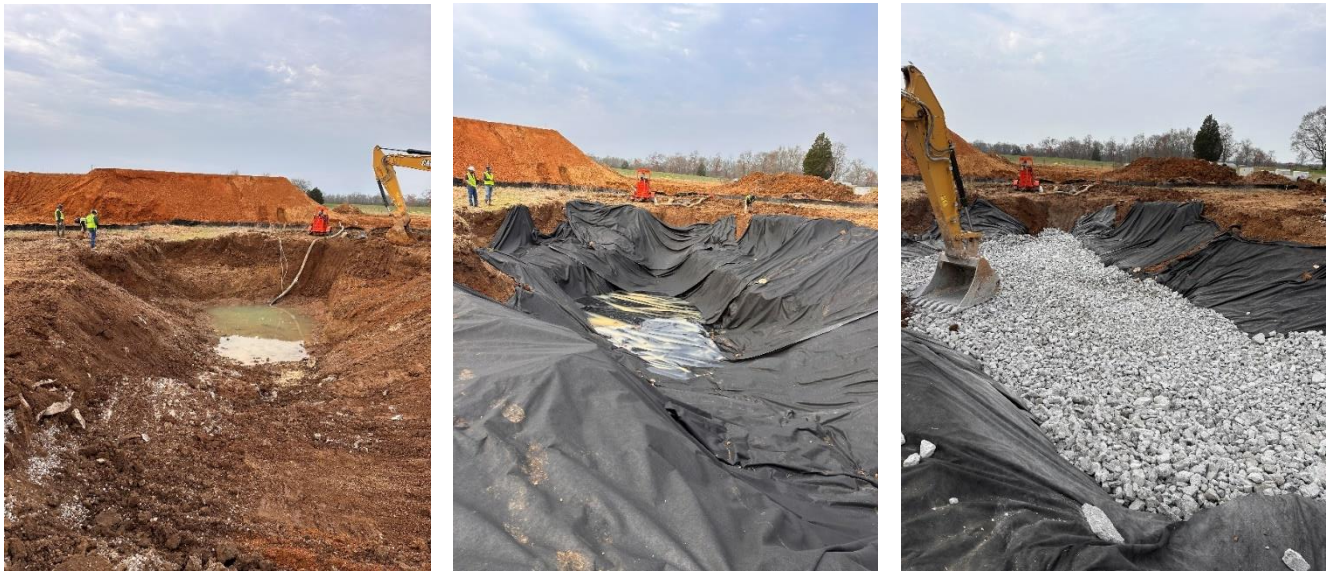
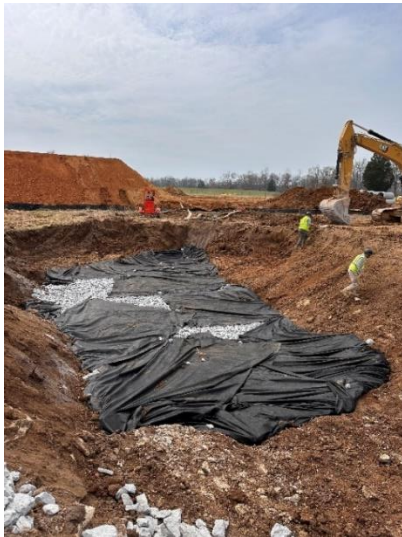
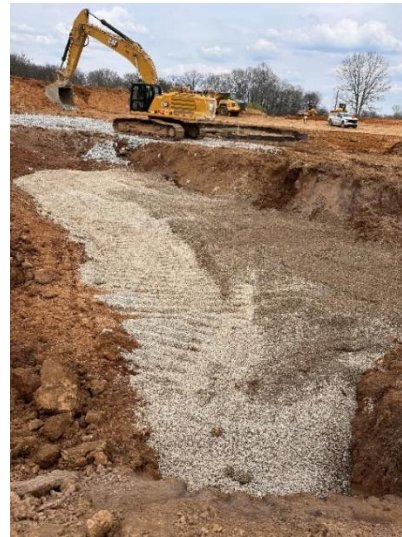
Figure 1. a to e) Sinkhole Remediation via Inverted Rock Filter

Sinkhole repair entails restoring affected infrastructure and preventing further subsidence. Excavation and backfilling are commonly employed to fill collapsed sinkholes and rebuild damaged foundations. However, conventional repair methods may be insufficient for large or deep sinkholes, necessitating innovative solutions such as the use of geosynthetic reinforcements or soil stabilization techniques. In karst geologies, surface collapses during construction are a significant concern due to vibrations and water intrusion. The inverted rock filter method offers an economical and practical solution for remediation. This technique involves excavating the collapse area to the sinkhole throat, lining it with geotextile fabric, and filling it with rip-rap stone. The fabric prevents soil erosion while allowing water drainage, and the stone provides structural support. This method is suitable for pavement and slab areas but may require alternative approaches, such as concrete backfill, for collapses beneath foundations. Figure 1a to 1e illustrate sinkhole remediation via inverted rock filter method.

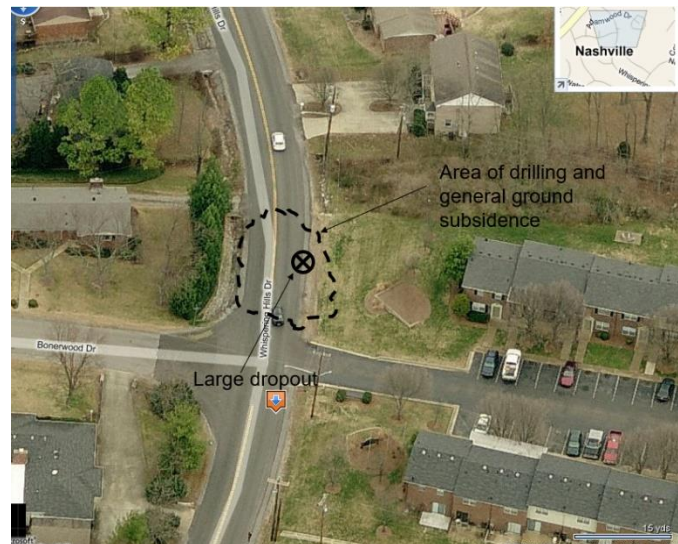
Figure 3. a) Site location, and b) the approximate location of dropout within the roadway

The sinkhole is situated on Whispering Hills Drive just north of Bonerwood Drive in Nashville, Tennessee. Whispering Hills Drive is a two-lane asphalt roadway, approximately 30 feet wide, sloping gently downward to the north-northeast. Subsidence, spanning the width of the travel lanes, is visibly apparent along a segment of

approximately 50 feet in length. Additionally, an isolated dropout of approximately 6 feet in diameter is observed in the east (northbound) lane of the roadway. Within the affected area, there reportedly exists a 36-inch diameter water main and a 12-inch diameter water line. A storm drain traverses through the pavement subsidence area, located along the eastern end of the pavement. A stone-lined ditch is situated on the western side of the roadway. This problematic area has been a persistent issue for several years. Personnel from Metro Public Works recall visiting the site in the late 1990s, observing isolated dropouts and subsidence related to soil piping. It appears that conventional sinkhole repair methods involving excavation of overburden and placement of rock fill have been implemented on multiple occasions since then. The most recent repair of the pavement settlement area, reportedly conducted about four months ago, involved the removal of asphalt pavement and undercutting of the soft subgrade soils to an unspecified depth. The undercut area was subsequently backfilled with crushed rock fill, topped with a thick layer of asphalt pavement. However, noticeable and measurable subsidence, along with a significant dropout, occurred shortly after the repair efforts, prompting the initiation of the current exploration and study to investigate and mitigate the issue. The affected section of the road has been closed to traffic since the latter part of May 2009. The site location map and the approximate location of dropout within the roadway are depicted in figures 3a and 3b respectively. Figures 4a to 4k also illustrate the existing site situations and dropouts and subsidence along the driveway on the site.

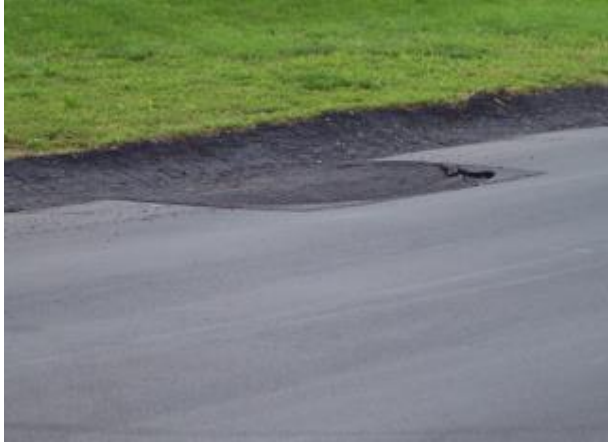
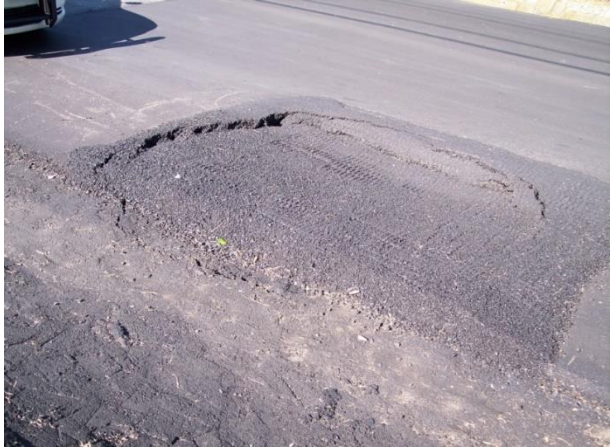
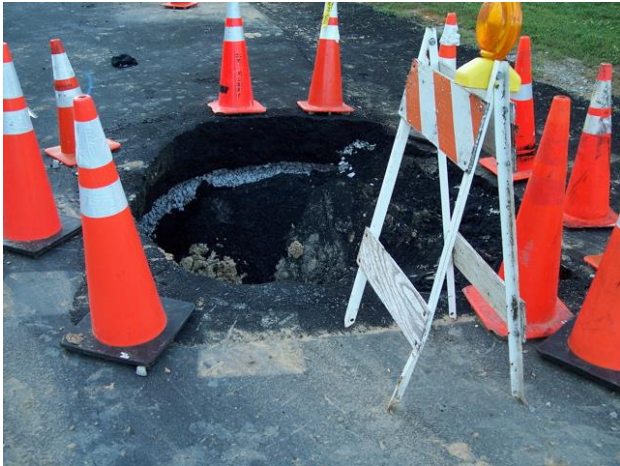
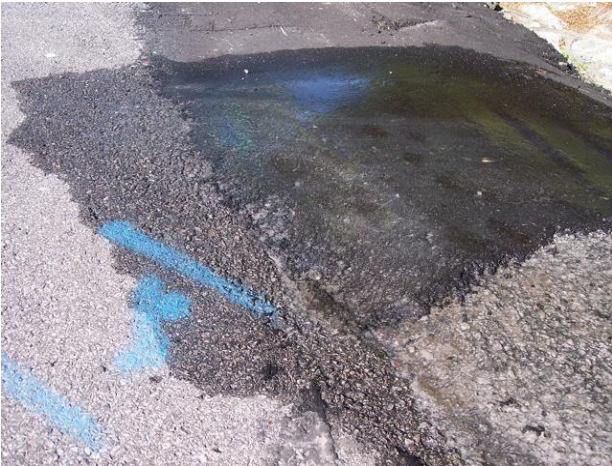
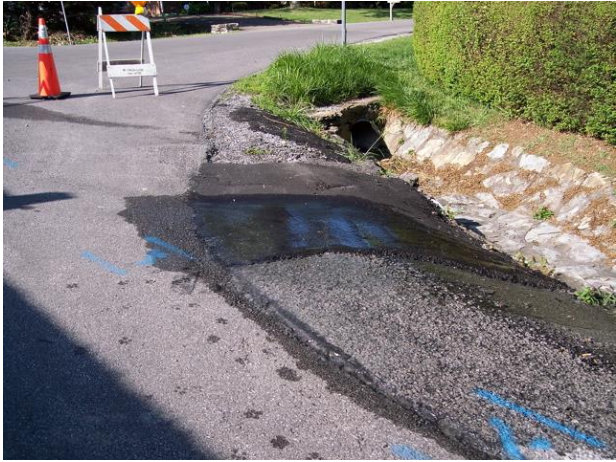
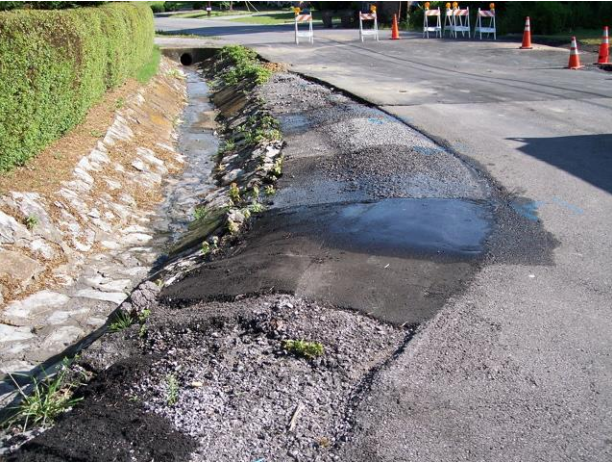
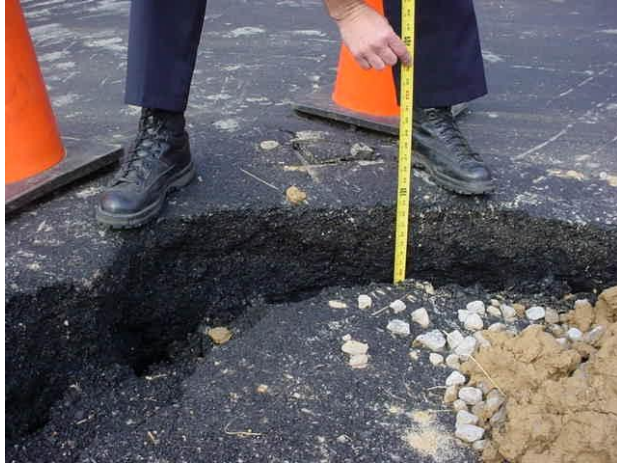
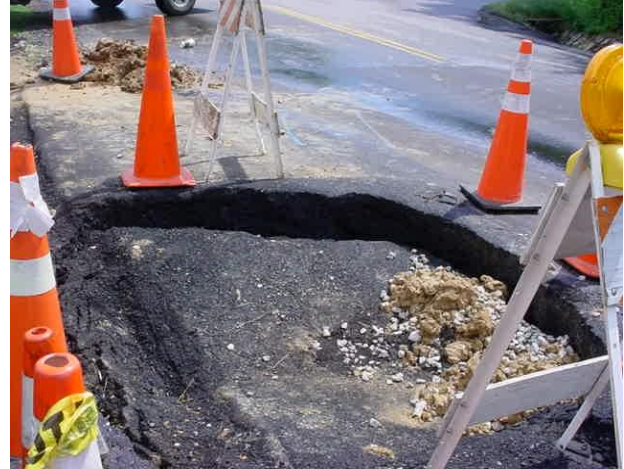
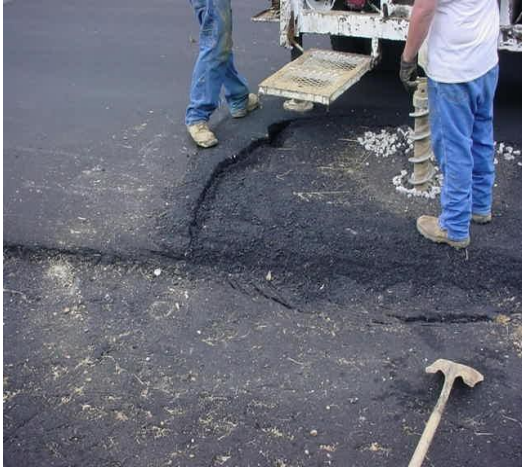
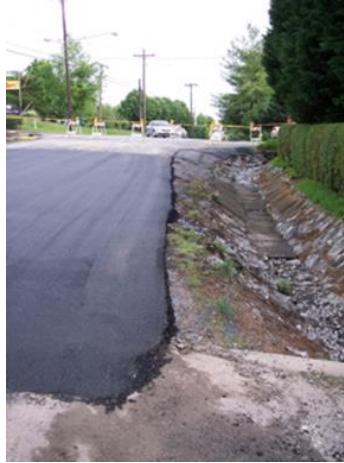
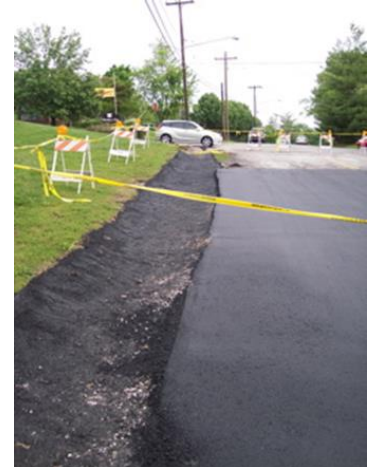
Figure 4. a to k) the existing site situations and dropouts within the roadway
